IABSE Symposium 2019 Guimarães
Towards a Resilient Built Environment - Risk and Asset Management
March 27-29, 2019, Guimarães, Portugal

Structural performance of the church of São Miguel de Refojos

Rafael Ramírez; Nuno Mendes; Paulo B. Lourenço

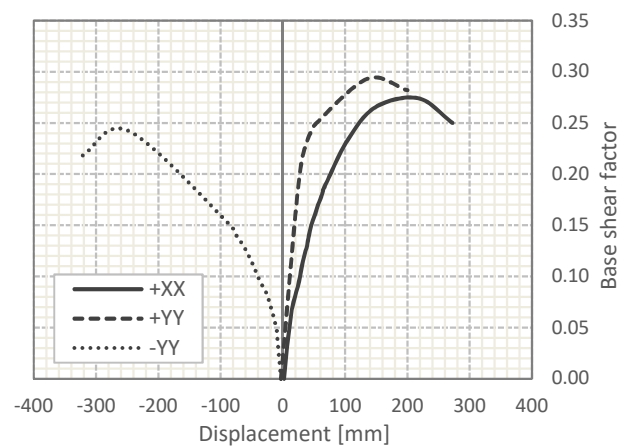
Figure 4. Capacity curves for pushover analyses.
 Control point at the top of the south tower

The pushover analysis in the negative longitudinal direction (-YY) presents a maximum base shear factor equal to 0.24 g (Figure 4). This value represents the lowest capacity obtained from the different pushover analyses, and therefore indicates the most vulnerable direction of the church. This response is associated with a

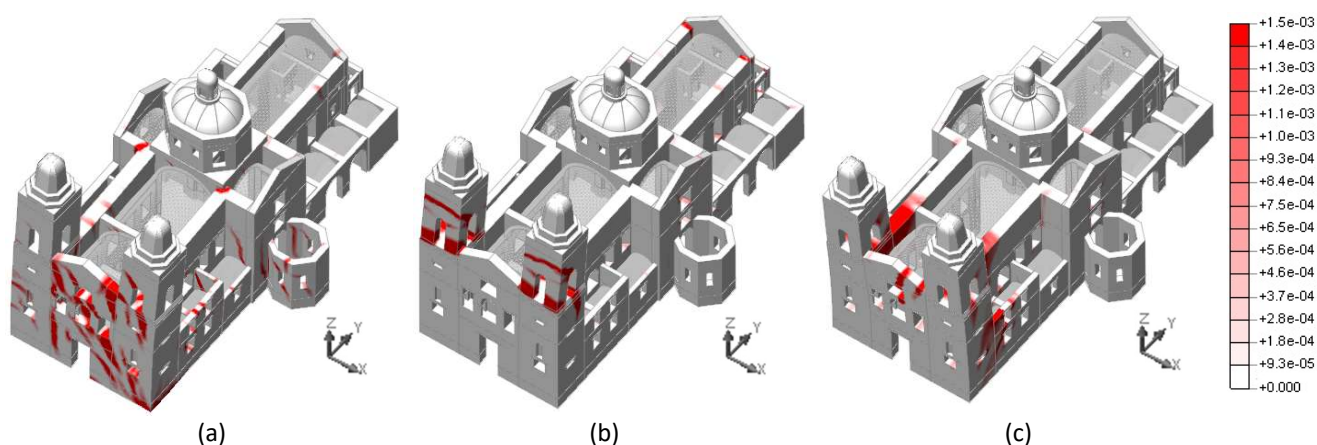
Figure 5. Crack width associated with the maximum principal strain at the end of the capacity curve for pushover analysis: (a) +XX; (b) +YY; (c) -YY. (Units: m)

The seismic analysis in the positive transversal direction (+XX) indicates that the maximum horizontal capacity is equal to 0.28 g (Figure 4). The horizontal maximum displacement occurs at the top of the south tower. The damage pattern is characterized by shear cracks in the plane of the walls and cracks in the connections between structural elements (Figure 5a). The most severe damage occurs in the main façade (diagonal cracks) and in the connections of the south tower with the orthogonal walls.

The capacity curve, with displacement control at the top of the south tower, indicates that the maximum capacity of the church in the positive longitudinal direction is equal to 0.29 g (Figure 4). The maximum displacement occurs at the top of the towers. In fact, the main failure involves the local collapse of the belfries (Figure 5b). In addition, there is also damage in the connections between the rear façade and the longitudinal walls of the chancel.

significant deformation of the main façade and the towers in the out-of-plane direction (Figure 5c). The damage pattern is characterized by cracks in the connections between the towers and the longitudinal walls of the nave as well as vertical cracks in the main façade.

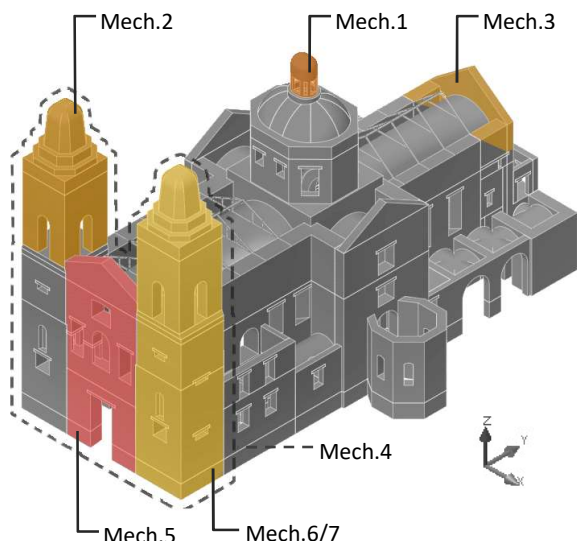
- Mechanism 1: Overturning of the lantern with rotation at the base;
- Mechanism 2: Overturning of the belfry with rotation at the base;
- Mechanism 3: Overturning of the gable of the rear façade (high altar) with rotation at the base and diagonal wedges from the lateral walls of the chancel;
- Mechanism 4: Overturning of the main façade and towers with rotation at the base;
- Mechanism 5: Overturning of the main façade with rotation at the base;
- Mechanism 6: Overturning of the southwest tower with rotation at the base in the direction perpendicular to the façade;

- Mechanism 7: Overturning of the southwest tower with rotation at the base in the direction parallel to the façade.

Figure 6. Collapse mechanisms considered for limit analysis

It must be noted that these collapse mechanisms were defined based on expert opinions and typical failures caused by earthquakes, which can be different from the failure modes obtained from the pushover analysis. The results of the limit analysis for the seismic action are shown in Table 3. The maximum capacity of the considered mechanisms varies between 0.09 g and 0.53 g. The lowest capacity corresponds to the partial mechanism of the façade with vertical cracks in the connections with the towers. This mechanism is extremely conservative and implies a very poor connection between the longitudinal and transversal walls. There is no current damage or reasonable suspicion that indicates a poor quality connection between these walls.

Mechanism 2, which corresponds to the collapse of the belfry of the towers, has a maximum capacity of 0.48 g, which is significantly higher than the capacity obtained from the pushover analysis in the positive longitudinal direction (0.29 g). However, it should be noted that the collapse obtained from the pushover analysis also involves diagonal cracks in the columns of the belfry (Figure 5b), which differs from the mechanism proposed for the limit analysis (horizontal cracks at the base of the belfry).

Mechanism 4 (overturning of façade and towers) corresponds to a failure mode also observed in the pushover analysis (Figure 5c). In this case, the maximum capacity obtained from both approaches is the same (0.24 g).
